Ultra Low K (ULK) Reflector Repair

amcoss Refurbishment Process for ULK Reflectors

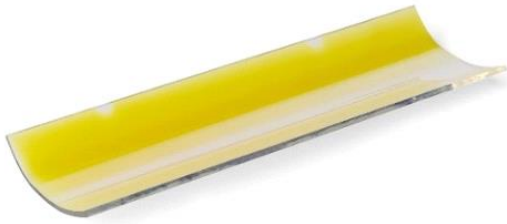
The ULK reflectors within the AMAT or Novellus equipment are grouped around the UV lamp. They are subject to enormous thermal stress, causing the coating to come off after some time. As a consequence: reflection of the UV light and uniformity noticeably deteriorate.

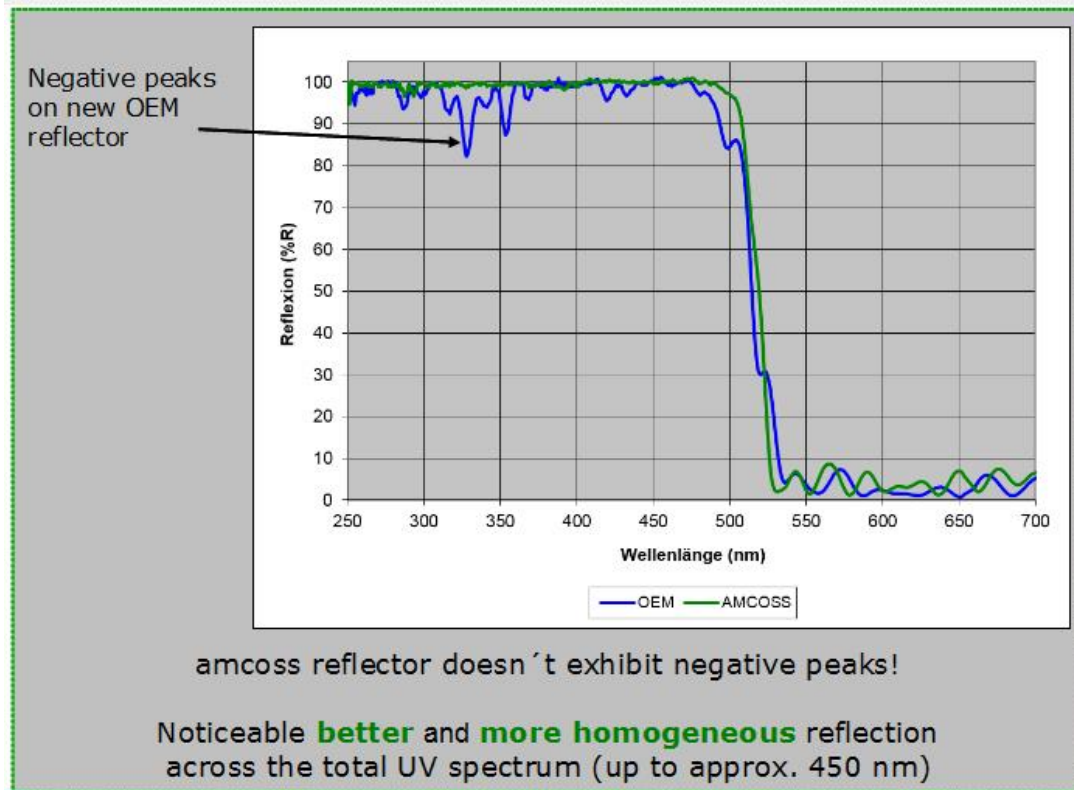
Reflection Comparison – new OEM vs. refurbished amcross ULK Reflector

The reflector refurbished by amcoss with regard to intensity, uniformity and operating life resembles a new one. Its reflection values are even better and more homogeneous than those of a new OEM reflector.
